TRAIN DERAILMENT AT
GRAYRIGG, CUMBRIA
23 FEBRUARY 2007

RAIB INTERIM REPORT

ISSUE DATE : 26 FEBRUARY 2007

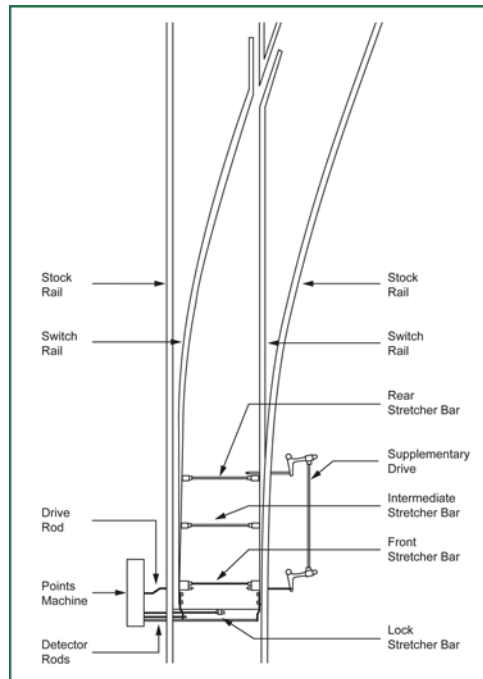
Figure 2: Diagram of switch and stock rails and stretcher bar

26. The design of the facing points² at Lambrigg had one lock bar and three stretcher bars.

27. Investigation of the lock and stretcher bars in the facing points at Lambrigg crossover showed that one of three stretcher bar was missing, and bolts that secured the lock bar and another stretcher bar were not in place – some of these bolts and the associated nuts and washers were found in the ballast, but others were not. However, the RAIB search of the area has not been completed. There is no evidence that the bolts had been wrenched free. Two of the stretcher bars were fractured; in one case the nature of the fracture surface indicates that it may have been consequential to the derailment. In the other case, the fracture surface indicates that it may have predated the derailment. The latter will be confirmed by further analysis.

28. There was therefore no complete stretcher bar in place between the switch rails immediately before the derailment. The left hand switch rail was free to move across close to the left hand stock rail whilst the right hand switch rail remained, correctly, against the right hand stock rail.

29. The marks on the crossover at Lambrigg indicate that at the time of the derailment both switch blades were in contact or very close to their respective stock rail. The train wheels were thus set on a course where the gauge was narrowing as the train moved forward. The train wheels, (which are rigidly mounted on an axle a fixed distance apart), could not follow the narrowing route and climbed over both switch rails, and then ran in a derailed state.

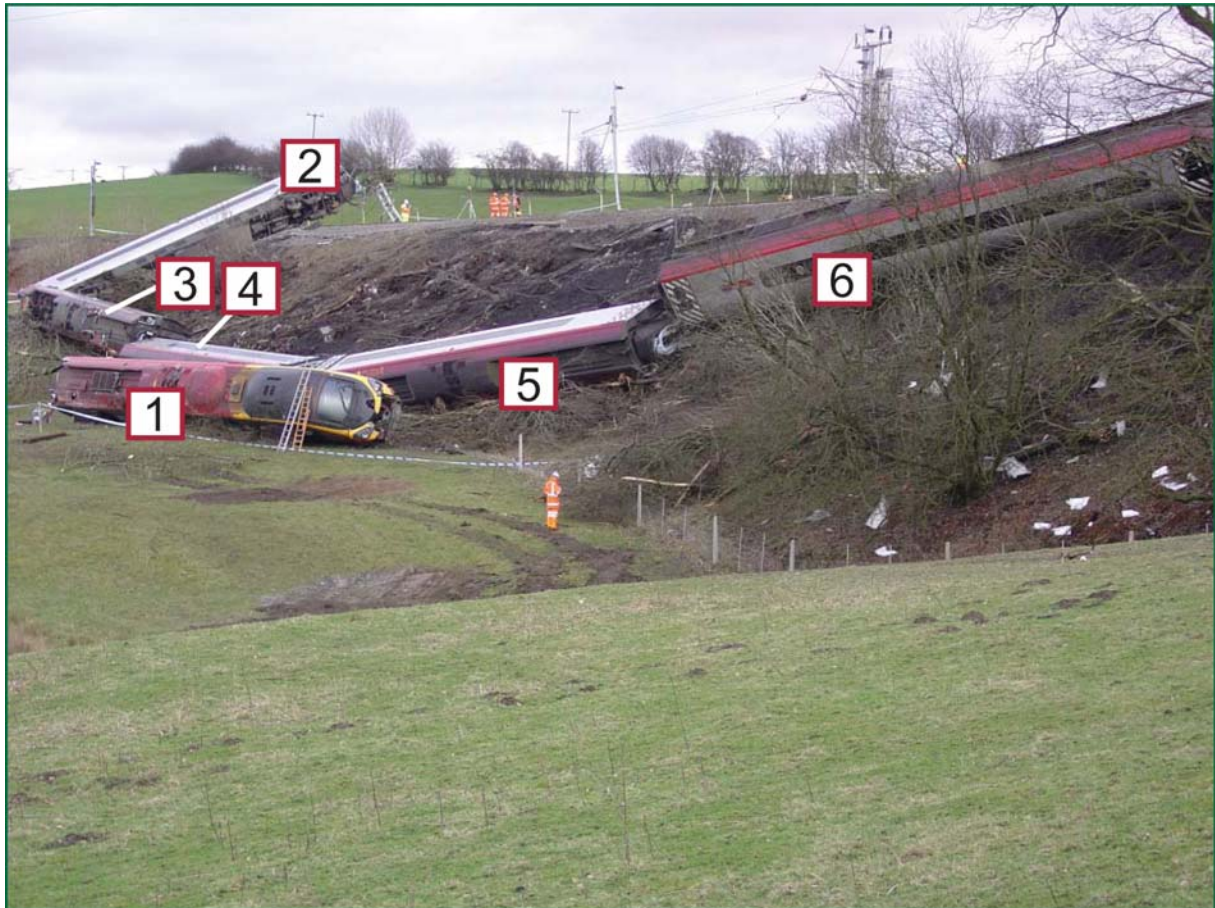
Figure 3: Photograph of derailed train with carriages numbered.

35. Key aspects of the damage are:

- The trailing bogie of the first carriage and the trailing bogie of the fifth carriage separated from the carriage bodies. There was no further consequential damage from this.

- The front end of the leading carriage suffered damage, but the crashworthy structure appears to have performed as designed, and the windscreen was not broken.

- The leading carriage was separated from the second carriage, and out of line as described above.
- The second carriage was separated from the third carriage, and out of line, lying on the embankment slope almost perpendicular to the track.

- All other carriages remained in line, but the gangways were separated. At this stage it has not been possible to establish whether the couplings held in all cases.

- The leading end of the second carriage hit an overhead line stanchion, causing damage to the vestibule area, but not affecting the passenger compartment.

- The overhead line pantographs on the third and seventh carriages remained intact.
- There are broken windows on the left hand side of the second carriage, and probably on other carriages, but these have not yet been examined as the carriages are on their sides.

- There are isolated broken windows on the right hand side of the train, but this may be a result of emergency service recovery of the passengers.
